Significant Incident Alert

Type of Incident Trailer # T201 Fire
Key Issues Internal Brake line Air Leak
INX Incident No 53634
Date & Time 30th-January -2021, 1430hrs
Location KM40
Injury Nil Injury

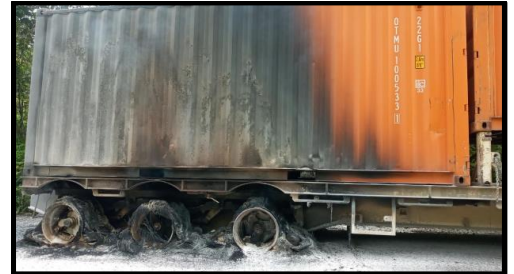
At approximately 1340hrs, Line Haul Trailer #T201 attached to Prime mover (VT11) caught on fire at KM40. It is believe that the fire started at the rear section of the trailer which engulfed all 12 tyres on both sides of the 3 x axles.

1. Volvo Vehicle systems familiarization to be undertaken for refresher by transport operators and built into VOC driving competency for all Transport Drivers
2. Implement QA/QC testing systems/procedure for post trailer repairs and include in the standard work process.
3. All transport drivers to undergo refresher fire extinguisher training
