Type of Incident	Medical Treatment Injury
Key Issues	Assessing Risks properly prior to undertaking work.
INX Incident No	ID 116934
Date & Time	Friday, 31 st March 2023, 02:20 AM
Location	Underground Tunnel – Drill Cuddy 2
Injury	Degloving injury to the tip of the right thumb

DESCRIPTION

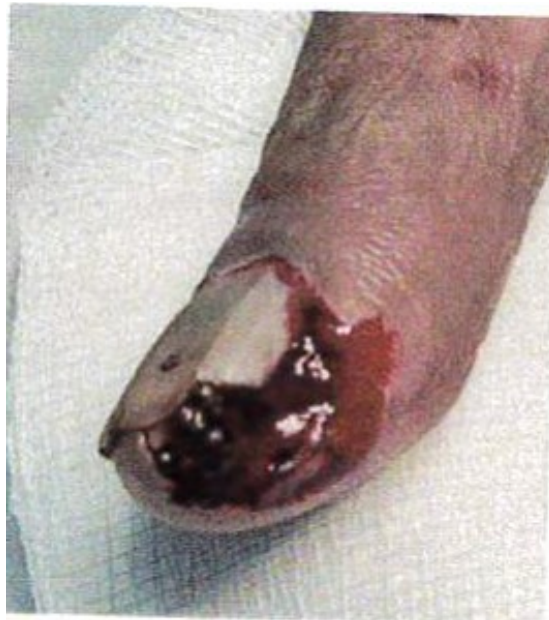
On the 31st of March 2023 at approximately 02:20 hrs, whilst drilling underground to pin a face collar plate for DeepCore Rig 8, the air-leg drill slid, in an attempt to stop the drill from falling, the off-sider had his right thumb squashed.

- Review and update Pneumatic Leg drill hammer operating Procedure and include the following;
 - Design and fabricate Elevated Work Platform for the air leg rock drill hammer to elevate and reach the proposed drill collar height.
- Safe handling of sliding vibrating rock hammer to be included in SWP, induction and onsite training and shall be documented.
- Compile specific JSA for operating air-leg drill and maintain continuous review on site before executing a task involving airleg drill.
- Coaching and awareness to the crews on the take-5, JSO and JSA process and duty of care for each other.
- Underground Leading hands and trainees to attend ASA Behavioural (ASAB) Safety Coaching.
