Type of Incident	Near Miss - High Potential
Key Issues	Substandard lifting practice – Lifting using loader bucket teeth
INX Incident No	133693
Date & Time	Monday, 28 th August 2023, 3:00PM
Location	Geneva Ridge – Starwest workshop.
Injury	Nil.

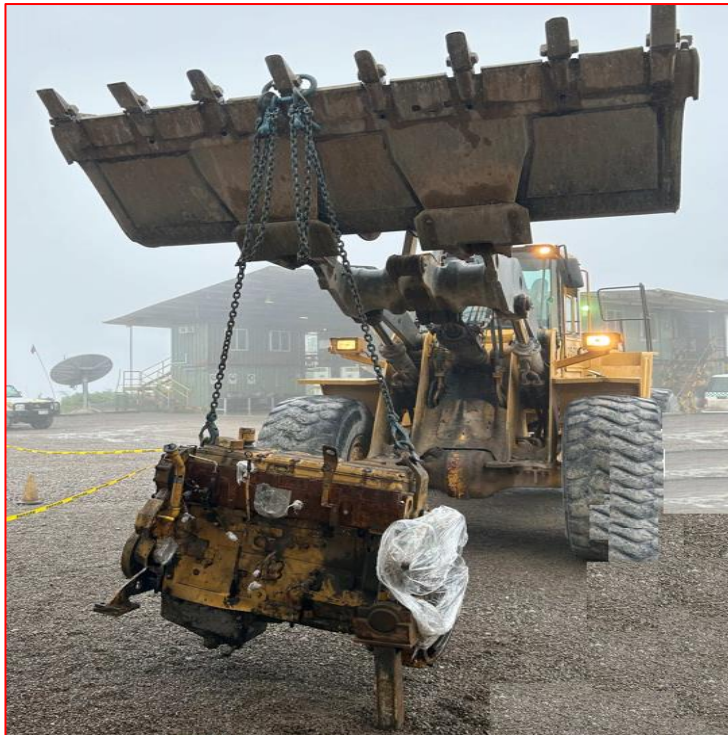
During the 3rd quarter of MRA inspection audit visit to Geneva at Starwest workshop and quarry operation on Monday, 28.8.2023 at around 15:00 hours, the NM incident was identified that an engine component of a dozer with estimated weight of about 1.5 tone was hooked onto a single bucket tooth of wheel loader and lifted whilst an employee was working under the suspended load in preparation to set up a stand to place the engine component. High Potential Near Miss Incident INX# 133693 August 2023. Refer to the OTML Intranet INX for controlled version. At that instance, a boiler maker was assigned to setup a stand for the D9T dozer engine at Geneva boiler maker Workshop. When in the process, an engine was on the ground and a boiler maker secured the engine with the chain to the wheel loader bucket tooth before lifting, the two employees (loader operator & boiler maker) were using a wheel loader bucket tooth as a lifting point to lift 1.5 tonne D9T dozer engine whilst boiler maker was bolting stands onto the engine whilst the engine was suspended off the ground at about 800 mm. The MRA inspection team observed as an unsafe behaviour and practise (potential for the

sling to slip off the bucket tooth, and lifting a load with a bucket tooth that is not design for lifting purposes) which has the potential for someone getting hurt or worst-case scenario of having a fatality at workplace.

- **Non-Compliance to Standards/Procedures** The controls/standards associated with the lifting is not comply prior to work, (including take 5, requirement to complete JSA) and do situational awareness or say NO to do the task if it is unsafe.
- **Lack of leadership/supervision** Ineffective supervision on the task to ensure it impact employee's performance in compliance to standards/procedures and task deliver safely without any significant incident.
- **Unavailability of tools & equipment (IT loader/Franna Crane)** The correct equipment for work (IT loader/Franna crane) is not available onsite (Geneva) to ensures the safety of the user (IP) but also increases staff productivity and efficiency. Especially when a worker is involved in a high-risk task. The right equipment can make the process fast and save IP from injuries. The IT loader was moved up to Vancouver workshop

- Re-iterate more on Take 5/JSA to all employees, and schedule for Advance Safety and Behavioural Awareness coaching (ASA &B).
- Permanently stationed a mobile franna crane and IT loader with operator for lifting to cover both Geneva and Mine operations Review and update shotcrete procedure to include minimum psi requirement when conducting shotcrete activities.
- Review Training Records for all employees on required statutory trainings including take-5s, CRM/JSA.
- Review all routine tasks at the workshop and document SOP/SWP
