Type of Incident Personal Injury – Restricted Work Injury (RWI)

INX Incident No 137773

Location Mine Maintenance Workshop – Dozer shop

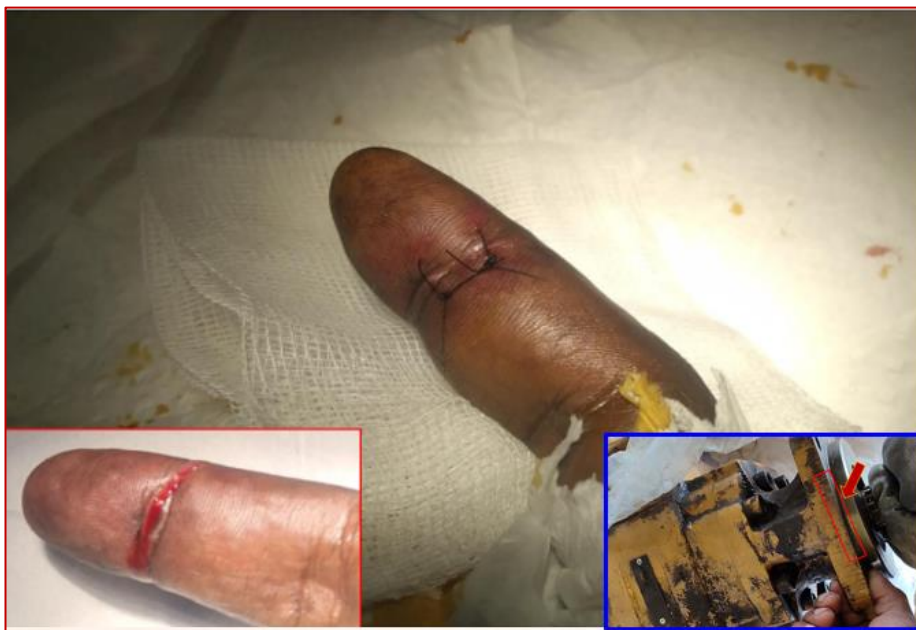
Employee was assisting his co-worker to manually remove Dozer D137 implement hydraulic pump from its packaging. During the process, the pump slipped, causing the sharp edge of its mounting flange to lacerate the Injured Party's (IP) right index finger.

IP received stitches on his finger and was put on seven (7) days restricted duties.

- IP lack attentiveness / awareness on the emerging task on unpacking the implement hydraulic pump.
- IP and co-worker overlooked combine risk assessment and basic take 5 on the emerging task.
- Lack supervision on the task to ensure safe execution, and check if any deviation on the assigned task.

- Review training registry on Critical Risk Management Training (JSA/Hazard Identification), and ensure all crews are covered.
- Develop a JSA for packing and unpacking of equipment parts at workshop.
- Realign iLEAD program to drive safety process and procedure when assigning daily tasks.
- Manual handling awareness presentation to cover all crews.
