## Significant Incident Alert

<b>Type of Incident</b>	Laceration to injured Person's left upper elbow.
<b>Key Issues</b>	Lack of Situational Awareness
<b>INX Ref No</b>	95629
<b>Date &amp; Time</b>	Saturday, 06 <sup>th</sup> August, 2022 @ 8:45pm
<b>Location</b>	Central Engineering workshop
<b>Injury</b>	Medical Treatment

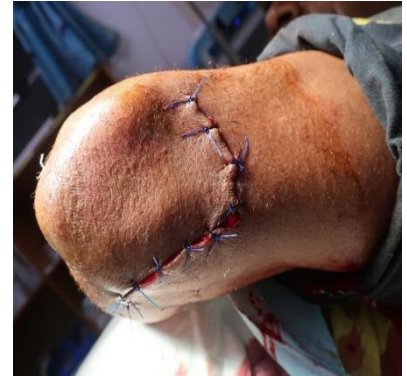
IP shifted the Lathe gear to neutral mode and the machine was in the process of slowing down when the rotating chuck caught onto one of the long curly metal chips and swung it toward IP's direction. The curly chip contacted the IP's left posterior arm resulting in a laceration to his upper elbow.

- Inspect all rotating equipment to ensure proper guards are installed
- IP and Leading Hand to attend ASA coaching - Lacking of Safety and Situational Awareness
- Review SWP to include metal chip management process and communicate to workers
- Communicate to workers on use of PPE according to its designed purpose
- Replace worn cutting tips.
