Significant Incident Alert

Type of Incident	Significant Structural Failure
Key Issues	0343TM01 Gundagai Thickener feed well, drive shaft and rake arms damaged during un-bogging activities
SAP Incident No	Incident ID 101699
Date & Time	Wednesday 19 th October, 2022 @ 09.40am
Location	0343TM01 Gundagai Thickener
Injury	Nil

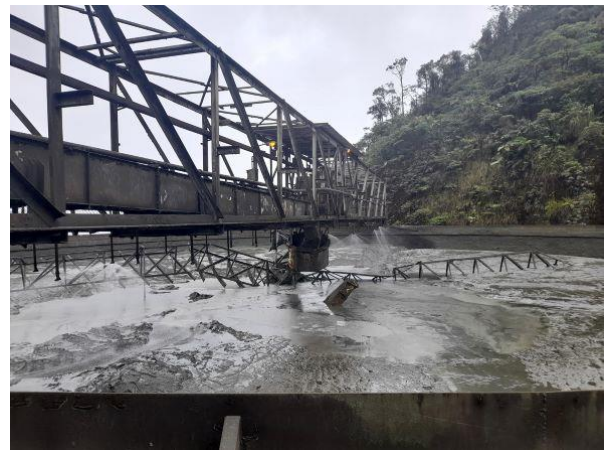
On 19th October 2022 at around 09.40am, the feed well, drive shaft and rake arms were damaged during un-bogging activities.

High-pressure hosing around the thickener walls caused large slumps of CuCon to slide towards the centre of the thickener dragging/pulling one of the rake arms and shaft sideways which also impacted the feed well. This resulted in damage to the feed well, the drive shaft and the rake arms.

- ❑ Review of Electrical Manning during TPO/TPS shutdowns.
- ❑ Operations to develop a SWP to manage thickeners during TPO/TPS activities.
- ❑ Review SWP for Thickener Hose-out to improve controls around bogged thickeners.
- ❑ Install bed mass pressure unit for 343TM01.
