## Significant Incident Alert

**Type of Incident** Light Vehicle – Station Wagon  
**Key Issues** Fatigue Management  
**INX Incident No** 106487  
**Date & Time** Saturday, 10<sup>th</sup> December 2022. 06:38hrs  
**Location** Tabubil – Mine Access Road. KM139.5

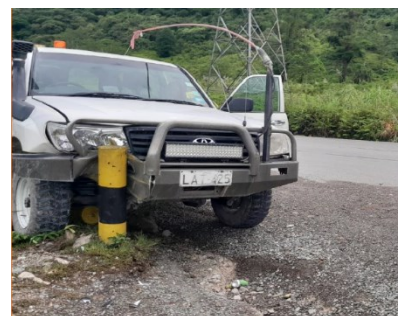
Deepcore Light Vehicle LVD89 travelled past the town water treatment tank heading towards the Trader's bus-stop at KM 139.5. LVD89 veered onto the right side of the road, just before the bus stop, and then came to a stop when it contacted a bollard.

The driver of LVD89 had just completed his night shift and reportedly experienced a micro sleep, the lone driver, or any member of the public, did not sustain any injuries.

- ❑ Establish a satellite equipment workshop / parts stores for critical spares.
- ❑ Review LV fleet with intent to identify opportunities to reduce LV usage.
- ❑ Holistically review Fatigue Management.
- ❑ Review and update Trakpro system on fleet.
- ❑ Conduct ASA Behavioural Coaching for all drivers.
