Significant Incident Alert

Type of Incident	Discharge Spools Collapse at Column Cell 2
Key Issues	Pipe Support Failure & Stored Weight
SAP Incident No	Incident ID 94773
Date & Time	Monday 25 th July, 2022 @ 12.00pm
Location	Mill Flotation Building, Folomian
Injury	Nil

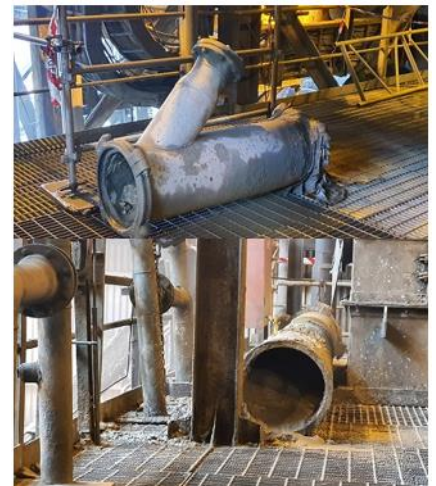
On 25th July 2022 at approximately 12.00pm, a steel spool pipe on the discharge line from column cell 2 collapsed. Approximately 4 hours later, a separate section of poly pipe on the same discharge line collapsed (15m away from the first).

There were a lack of pipe supports in the pipeline and several existing pipe supports had failed through corrosion. The pipeline had additional weight due to the accumulation of settled process solids.

- ❑ Review the design of existing pipe clamps and hanging supports for its suitability.
- ❑ Immediately inspect the condition of all pipe supports within the Process Plant.
- ❑ Update the Structural Assessment program to include pipe supports.
- ❑ Development and instigation of pipeline flush procedure.
