Type of Incident	Near Miss – High Potential
Key Issues	<ul style="list-style-type: none"> ▪ Mining on a confine bench, with absent of detailed TMP. ▪ Operator (IP) non-conformance to load & haul procedure.
INX Incident No	139249
Date & Time	Wednesday, 18 October 2023 4:30pm
Location	HX08 Mining Area Open Pit/East wall AI Bench
Injury	Nil

DESCRIPTION

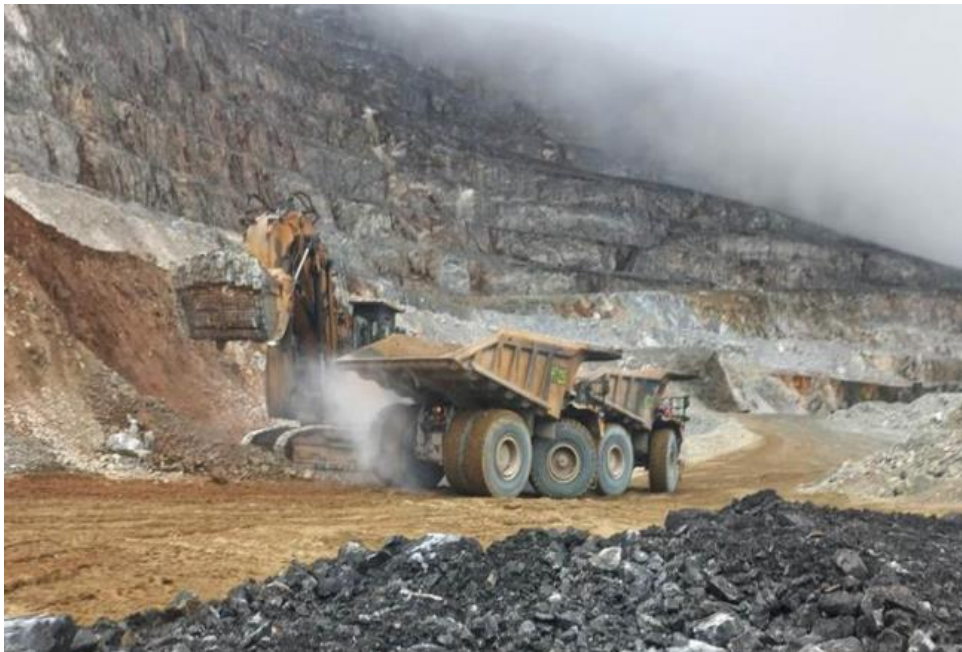
Haul trucks HT 225 and HT212 were getting loads from shovel HX08 mining area at AI bench East wall Open Pit. HT225 was already parked at the loading area besides Shovel H08 waiting to be loaded. HT212 reversed and its rear side tray came in contact with HT225 front left side resulting in damage to the boarding ladder and the front guard rail.

- Lack of situational awareness and inadequate risk assessment prior to parking and reversing into the shovel for loading.
- IP did not follow the sequence, took a short cut and parked at the blind side of the shovel that resulted with no visibility of other equipment especially to other truck operator.
- IP did not use the rear vision mirror and did not responded to the collision avoidance safe mine system

- Review planning on confine bench mining to include safe distance and traffic management plan (TMP) is placed on the ground prior to commencing work.
- Awareness on the situational awareness and risk assessment prior to work, and during loading and dumping.
