Significant Incident Alert

Type of Incident Lost Time Injury/ Injury/ Damage/ Loss
Key Issues Truck rollover
INX Incident No Incident ID 62731
Date & Time Saturday June 05, 2021 12:40 hrs
Location KM57 Kiunga/Tabubil Highway
Injury Soft tissue injuries to the body

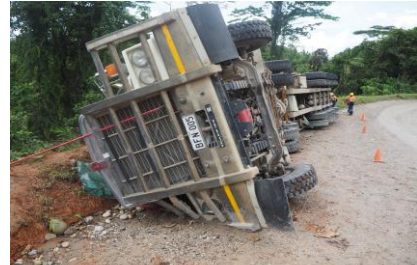
Damage/Loss TKI Linehaul Truck cabin damage/TKI loss business

A TKI Kenworth linehaul truck loaded with a Crusher Transfer Chute for Mill Processing rolled over at KM57 while negotiating a bend at an unsafe speed. Truck was in a convoy of 7 trucks and was on its way from Kiunga to Tabubil.

- ❑ Review linehaul procedure and load plan to include safe loading and method of securing before departure
- ❑ Review current road safety controls and improve road sign with Winding Road/Reduce Speed signages.
- ❑ Include monthly inspection to all linehaul fleets in compliance with TrackPro and ADAS
- ❑ Audit contractor partners with linehaul operation fatigue management system in line up with OTML management system.
