Significant Incident Alert

Type of Incident	High Potential Significant Near Miss Incident – TWRS Carter Truck veered off the road
Key Issues	A wrong selection of gear (3 rd) was applied while driving down the slope/hill on the sealed wet road condition
INX Ref No	8992
Date & Time	Tuesday, 24 th May, 2022 @ 3:36pm
Location	KM146.6 – Near Bultem Bridge
Injury	Nil

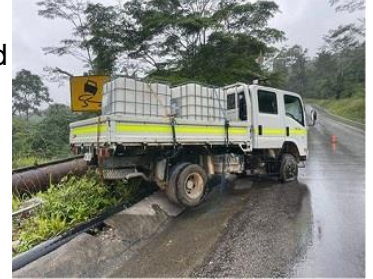
On Tuesday 24th of May 2022 at around 3:36pm, an Isuzu ceter truck fleet TWF003 belonging to Tabubil Workforce was travelling down from Mill to Ware House 127 in Tabubil. Whilst descending the slope section down to the Pratts Crossing around Km146.6, the truck picked up speed and driver applied the foot brake to slow the vehicle. The vehicle skidded and veered to the left and driver tried to regain control of the vehicle but overcorrected. The vehicle then veered to the right and hit the concrete spoon drain causing the vehicle to spin around before coming to rest facing back up to the Mill/Mine way.

- Business Partner TWRS to develop a detail SWP for Isuzu Carter truck's operation
- Milum Services Ltd Management to review its Safety Management Plan to include safe operation of equipment, maintenance of vehicles and ensuring driver competency and experiences for all its subbies.
- Light Vehicle VOC & Equipment training pack to be further reviewed and explore options to include defensive driving
- Explore the potential for Trakpro to monitor vehicle gear selection.
- Investigate options to install ADAS Camera in all Business Partners vehicles/trucks
