<b>Type of Incident</b>	Damage/Loss – Explosion/Fire
<b>Key Issues</b>	Partial discharge causing flashover between two phases of 11kV cables
<b>INX Incident No</b>	120126
<b>Date &amp; Time</b>	Tuesday, 02 May 2023, 18:15hrs
<b>Location</b>	Ok Menga Hydro Power Station
<b>Injury</b>	Nil

## DESCRIPTION

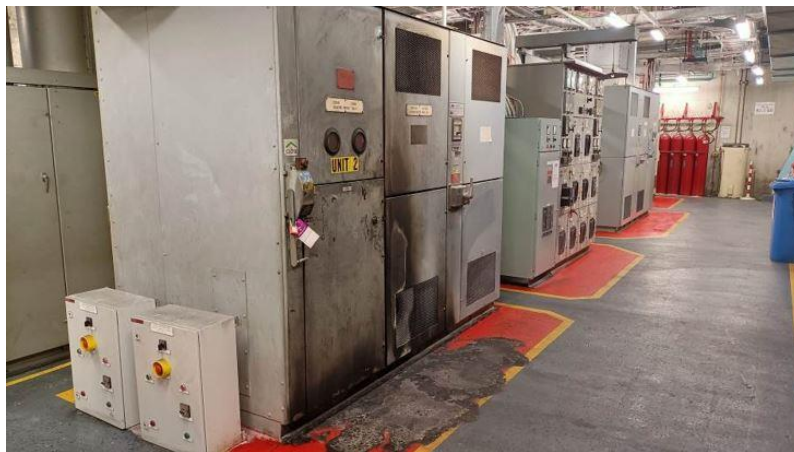
On Tuesday 2nd May 2023 at 18:15:55pm Ok Menga Hydro Generator 2 (GH02) initiated a normal start-up by the shift operators, when a loud noise was heard, and the generator tripped and displayed a number of alarms. The resulted of the loud noise which has revealed an Arch Flash within its Auxiliary System for 11kV to 415Volts protection zone. The fault initiated within the 2113XF0A2 Auxiliary transformer enclosure that resulted in the flash over when the arc emissions came in contact with rubber mat on the floor which resulted in a fire and generation of smoke.

- Repair the identified items that have failed or become unserviceable due to the event and return the Unit 2 Generator back to operational state.
- Review the design of the Ok Menga upstream protection currently installed and where identified as required upgrade or implement protection in line with current electrical requirements & legislation. This will include switch gear replacement in the same approved AFE. This will be part of the Approved AFE for AC Upgrade under PIP (POWER IMPROVEMENT PROJECT)

- Repair all areas where vermin ingress into the cabinets and integral wiring areas of both Unit1 & Unit 2 generators
- Review third party “Ok Menga Alternator Inspection” report actions and implement where required / identified
