| Type of Incident | Equipment Damage/Loss (Actual Consequence) Multiple Fatality (Potential Consequence) |
| INX Incident No | 119275 |
| Location | Km 20 Tabubil-Kiunga Highway - Miasomnai Village |

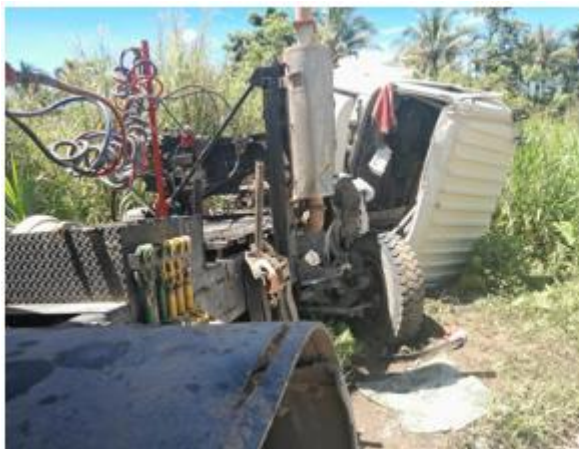
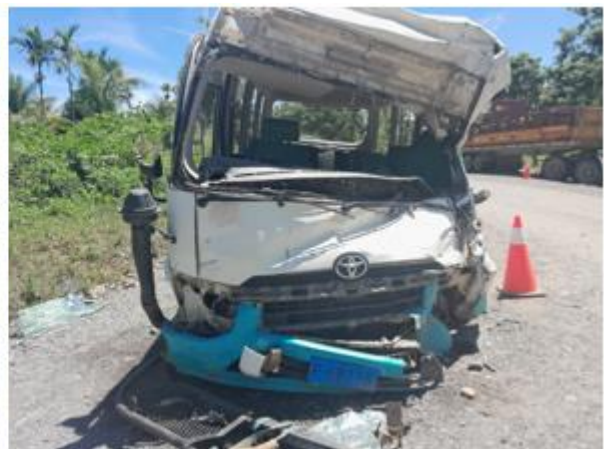
| Key Issues | <ul style="list-style-type: none"> The PMV driver was observed to be under the influence of alcohol. The PMV driver was observed driving erratically and at high speed through the village zone set at 40 km/h. The PMV driver (local and experienced) disregarded and broke the convoy procedures. |

A convoy operated by Starwest, consisting of an escort vehicle and two prime mover trucks, was travelling back to Kiunga from Tabubil after delivering Major Project materials. At Km20 at ~17:00hrs, a 25-seat Toyota Coaster public motor vehicle (PMV) overtook the last prime mover truck (Green Flag) and collided with the right side cabin of the first escorted prime mover truck (Red Flag). Both the PMV and the Prime Mover truck sustained significant damage from the impact.

- OTML CR, APD, OHS team and MVIL and Tabubil traffic police to conduct awareness to PMV drivers on the OTML convoy procedures, importance of wearing seatbelts and dangers of drink driving and speeding.
- Install signboards along the road side villages to make awareness on PMV user along Tabubil – Kiunga road to adhere to convoy procedures.
- Conduct toolbox talks and education of convoy operators and escorts, when encountering reckless driving, if safe to do so pull over and let them pass and report dangerous driving occurrence as near miss incident to their supervisor/escort leader, so APD can alert Local Police.
- Reinforce awareness and emphasis on the importance of wearing seatbelts.
