Type of Incident	Personal Injury- Medical Treatment Injury (MTI) High Potential Event
Key Issues	Driver experienced a momentary lapse of attention, resulting in a micro sleep episode (Fatigue)
INX Incident No	157013
Date & Time	Monday, March 18 th 2024, 17:46hrs
Location	KM 94 – Tabubil Kiunga Highway
Injury	Medical Treating Injury (MTI)

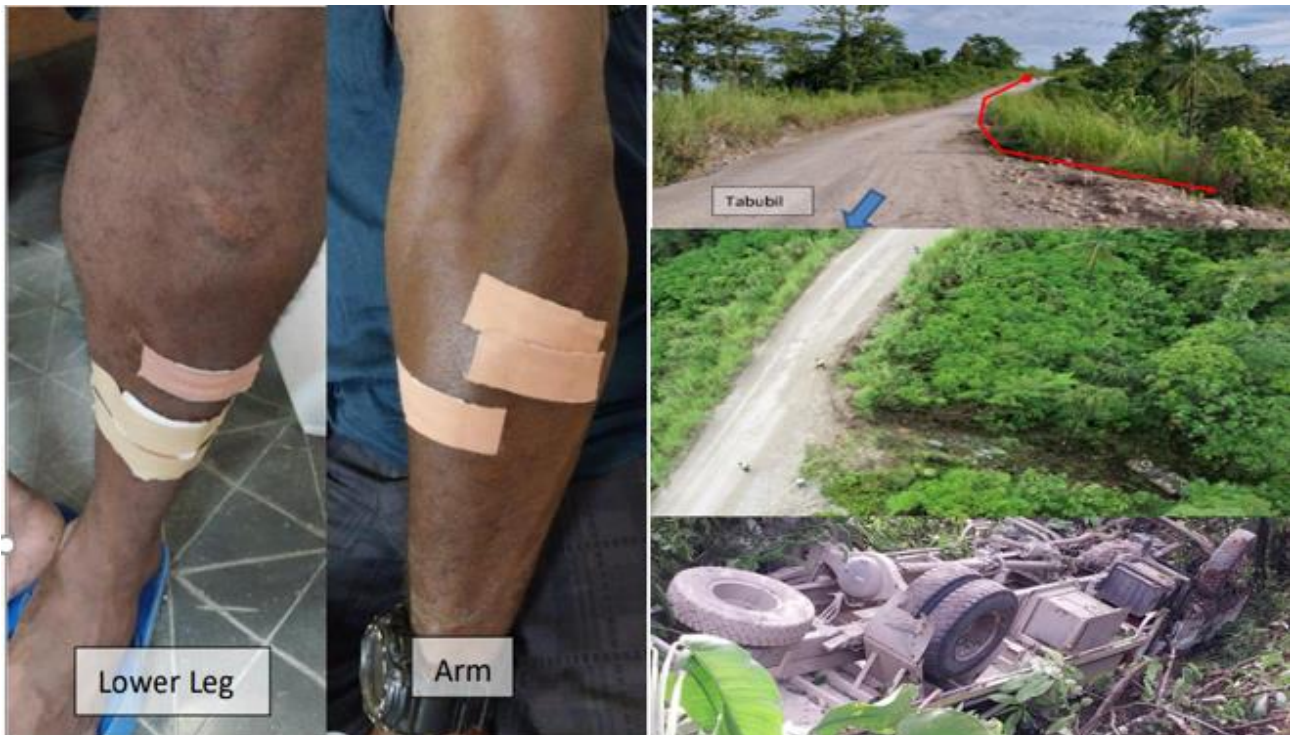
On Monday, March 18th, 2024, at around 17:46 hrs, the Milum Flatbed Tyre truck (Fleet F200) was en-route from Kiunga to Tabubil, following a Milum linehaul convoy. After departing from the 2nd rest stop point at Km66, the vehicle resumed its journey towards Tabubil. As it approached Kilometer 94 (Km94) and navigated through a narrow road section, the driver experienced a momentary lapse of attention, resulting in a micro sleep episode. This led to a loss of control of the vehicle, causing it to veer to the left and subsequently tip over when the front left wheel edged too close and went over the edge. Despite attempts to correct the trajectory, the vehicle rolled over 3 times down the gully, covering approximately 25 meters before coming to a halt.

Both the driver and the crew (Tyre Fitter) sustained minor injuries, including lacerations and bruises to the arm and leg.

- Enhance the Safety Management Plan (SMP) by implementing a structured review framework to enable systematic audits. These audits will ensure compliance with Standard Work Procedures (SWP) within Line haul operations. Additionally, emphasize strategies within the Fatigue Management Plan, particularly the Readwatch program, to uphold effectiveness and consistency.

- Plan and coordinate with relevant authorities to prioritise the widening of all narrow road sections along the Tabubil-Kiunga Highway, align these efforts with ongoing pilling projects initiatives to ensure effective implementation.

- Conduct a thorough review of the OTML TrakPro and ADAS Camera system to assess its effectiveness in detecting and alerting drivers of micro sleep events. Explore the feasibility of implementing a similar setup in Milum's main office to bolster safety measures and minimize the risk of fatigue-related incidents.

- Employee to undergo refresher ASAB coaching sessions conducted by experienced safety coaches who will educate employee about the signs and symptoms of stress, how it can affect their performance and safety on the job, and strategies for managing stress effectively.

- Review and update Standard Work Procedures (SWP) to include the tyre truck as part of the convoy fleet. Ensure that all vehicles involved in convoy operations are properly registered and accounted for in SWP and develop and alert protocol for drivers during the journey.
