Type of Incident	Damage/ Loss - Light Vehicle
Key Issues	<ul style="list-style-type: none"> No systematic process of conducting compliance check on high wall catch bunds to prevent falling rock onto access ramp. Design Audit procedure not audited and documented.
INX Incident No	151526
Date & Time	Friday, 02 February 2024, 1300 hours
Location	East Wall Top Moscow Ramp
Injury	Nil

DESCRIPTION

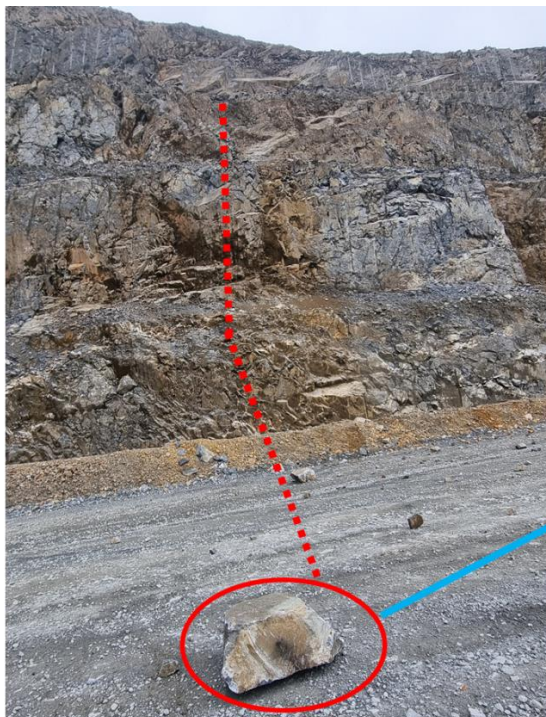
Rock fall at Top Moscow ramp that contacted LV0 989

On February 2nd, 2024, at 13:00hrs, at East Wall Top Moscow ramp, a rock fall incident occurred where a rock made contact with an Orica light vehicle LV0989 and damaged the left hand side (LHS) tale light. The vehicle with 2 personnel was driving approximately 14 meters away from the high wall bund at the time of the incident. Nil injuries sustained to personnel. Damage to rear end of vehicle.

- Ensure recommended operational controls are followed; bunds built to specification with rock fall Signage, single lane when required and temporary alternate route when risks is high.

- Investigate the option of cut-back or slope meshing/draping to prevent rock dislodge, for the longer term while continuing to manage risks using Corrective Action 1. Proceed with options that is practically timely.

- Awareness on blast clean-up and pre-cut process -ensure no loose material is left on the catch berm after pre-cut is complete (to ensure catch berm width is maximized before it is no longer accessible due to bench development).

- Awareness on wall scaling to completely free the wall face from loose rocks especially on areas in the pit design where main ramps (access) will be located.

- Review and create a systematic process of conducting compliance check on high wall catch bunds.
- Review and compile design audit procedure.

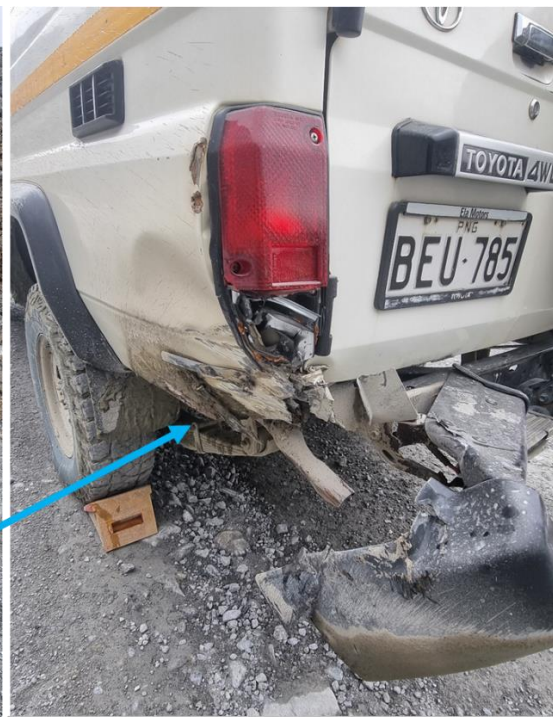
Orica Light Vehicle LV0 989 contacted by rock fall
