## Significant Incident Alert

<b>Type of Incident</b>	HPI – Near Miss
<b>Key Issues</b>	Equipment Integrity
<b>INX ID</b>	105306
<b>Date &amp; Time</b>	Friday 25 <sup>th</sup> November 2022
<b>Location</b>	Between Km 118 to Km 117
<b>Consequence</b>	Actual – Level 1 Potential – Level 5 (Multiple Fatality)

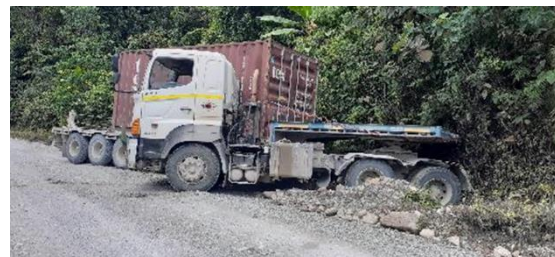
The operator managed to bring the prime mover and trailer to a stop on an incline, and then attempted to apply both the prime mover and trailer brakes. The prime mover and trailer started to move in a reverse direction back down the road ~57 m, where it then “jack knifed” before coming to rest on the side of the road

- Asset Maintenance - repair or replace faults identified on prime mover during post incident inspection, including all incident related damage.
- Asset Maintenance - conduct a review of all Starwest fleet that have pneumatic air braking systems. Update existing scheduled brake drum and shoe system checks service sheets to include brake pneumatic system checks applicable to the service interval and OEM requirements.
