Type of Incident First Aid Personal Injury

Key Issues **An employee sustained injury to the head who was exposed to both suspended rocks and an open edge whilst working on level two (2) of crusher conveyor CV 43 drive tower.**

INX Incident No 169030

Location Nurumi Crusher, Loop B, CV43 Drive Tower

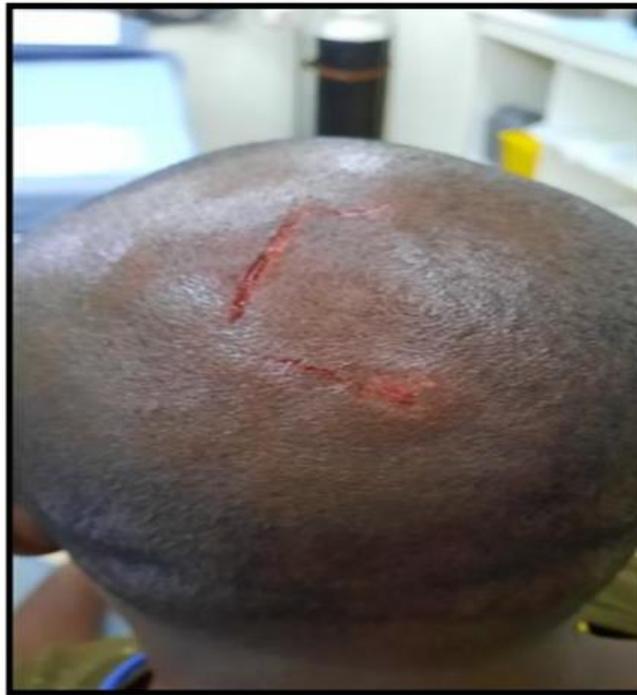
Incident photographs

On June 2, 2024, at around 12:25 PM, an employee at the Conveyor, CV43 Drive Tower, was hit by a trapped rock while working eleven (11) meters above the ground. The rock fell from about eight (8) meters above and landed on the hardhead causing the injury. This apart, there was a high potential of the Injured Person to fall down due to a missing handrail on the work platform where he was standing. The employee was not wearing a safety harness, as required by the JSA and Working at Height ATW permit.

- Ineffective risk assessment, to identify the hazards in order to apply appropriate controls.
- Inadequate identification and correction of missing handrails.
- Poor housekeeping and cleaning for safe shutdown work on the conveyor(s).
- Ineffective supervision & compliance with OTML Safety procedures.

- Re-instate missing guide rail (handrail & mid rail) at CV43 incident site.
- Install CV43 belt return side ore slip back spillage contain/catchment checker plates/trays to avoid rocks falling below the structures & onto basement of conveyor below causing personal injuries & equipment damages.
- Conduct audit and reinstall all missing handrails and machine guards along all the conveyors at Crusher.
- Review and develop detailed housekeeping procedure, for all work areas in the crusher & conveying areas and include in shutdown schedules.
- IP, Supervisor & work group to attend risk management training - including JSA, SWP write up training.
